2020 *Virtual* PROFESSIONAL ENGINEERS CONFERENCE

From Design to Disaster: Analysis of the Florida International University Pedestrian Bridge Collapse

Miami, Florida. March 15, 2018

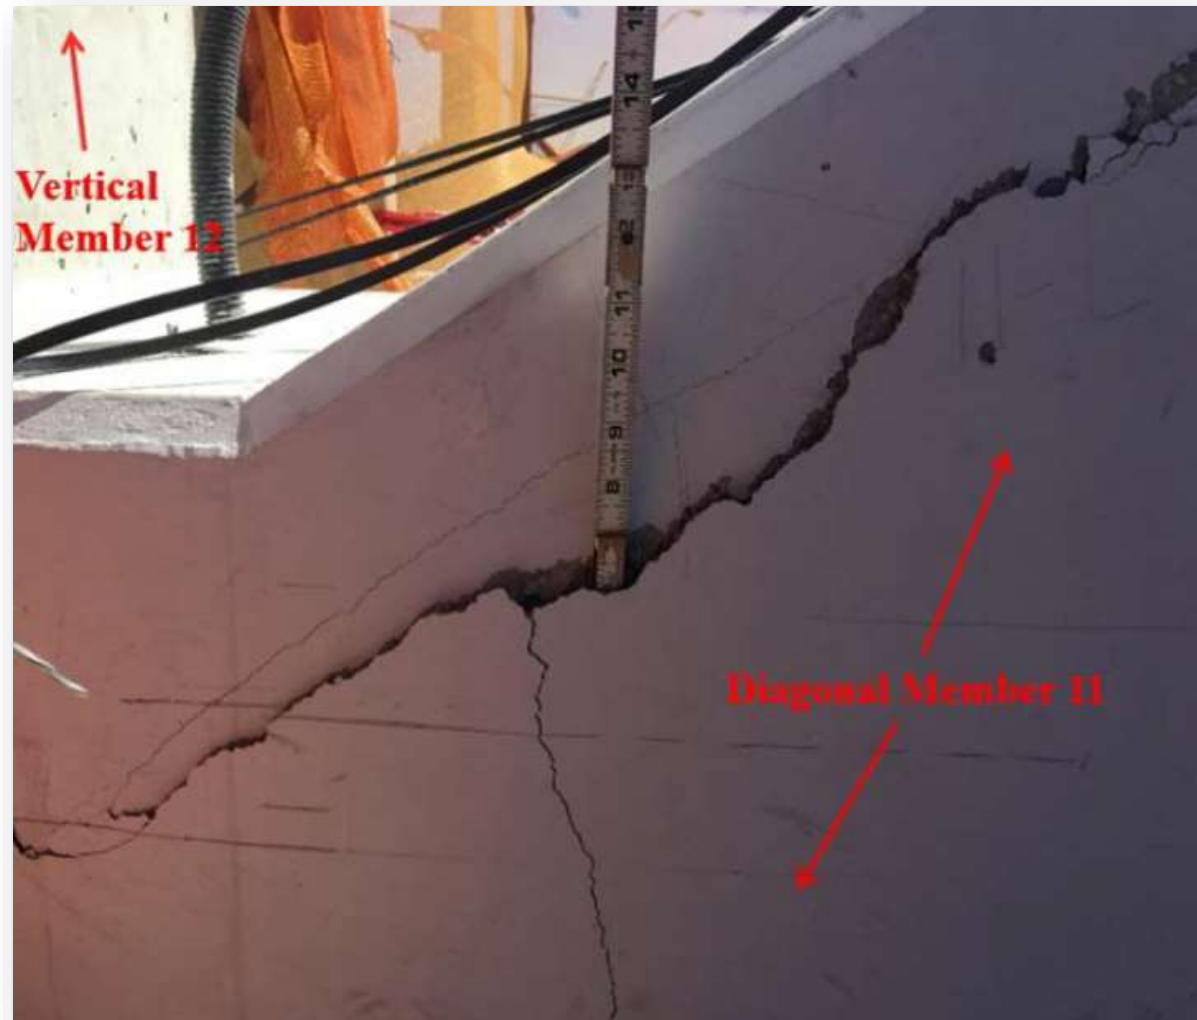
Cracking in Member 11/12 Nodal Region

- Structure showed notable cracking of reinforced concrete
- Extensive and large cracks in member 11/12 should have been recognized as abnormal
 - Cracks up to 0.016 inch wide – considered acceptable
 - Structural cracks in bridge were up to 0.75 inch wide – 40 times larger than typically acceptable
- Scale of cracking clear indication that load-resisting mechanisms were failing

load-resisting mechanisms were failing

- Scale of cracking clear indication that

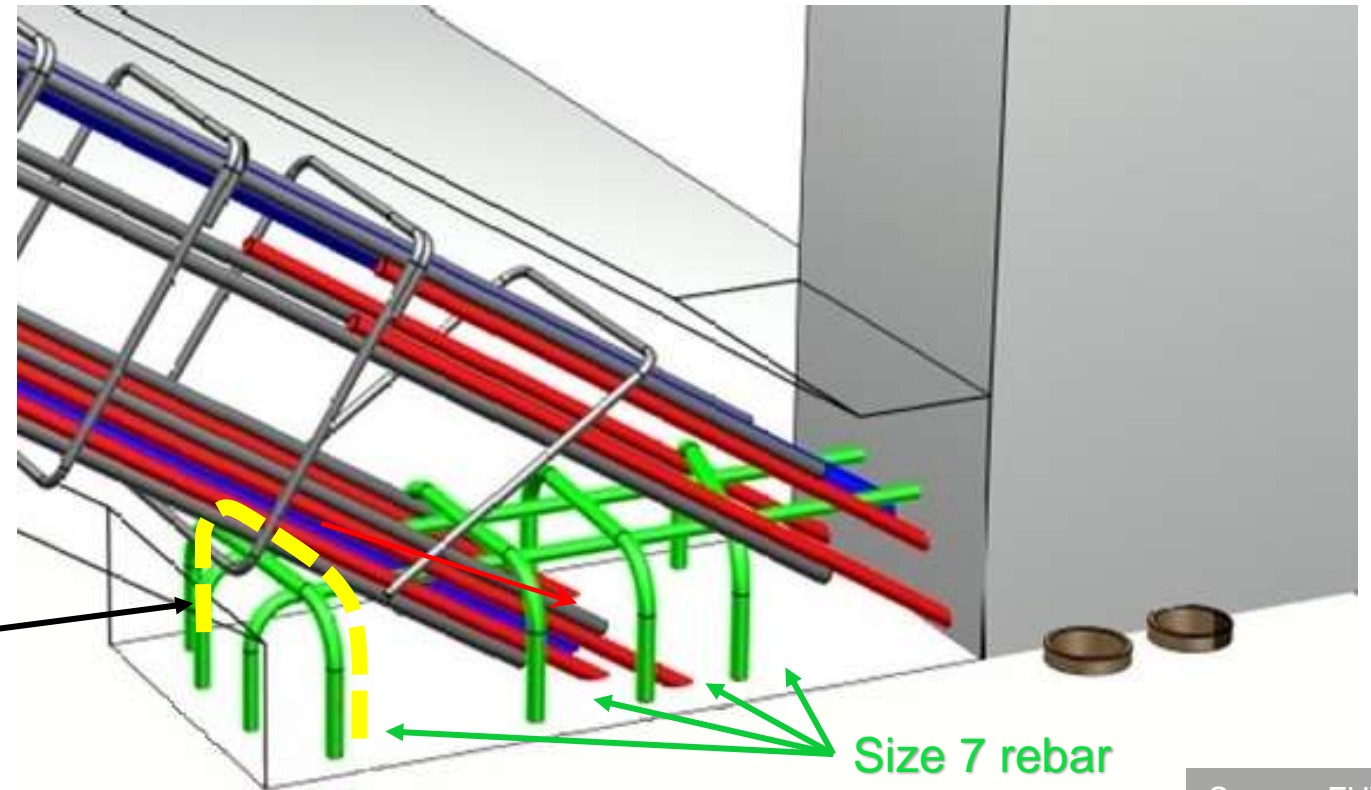
First Signs of Structural Distress

- Portion of crack bypassed 25% of reinforcing steel at base of member 11

Crack passed above the southernmost two size 7 rebars

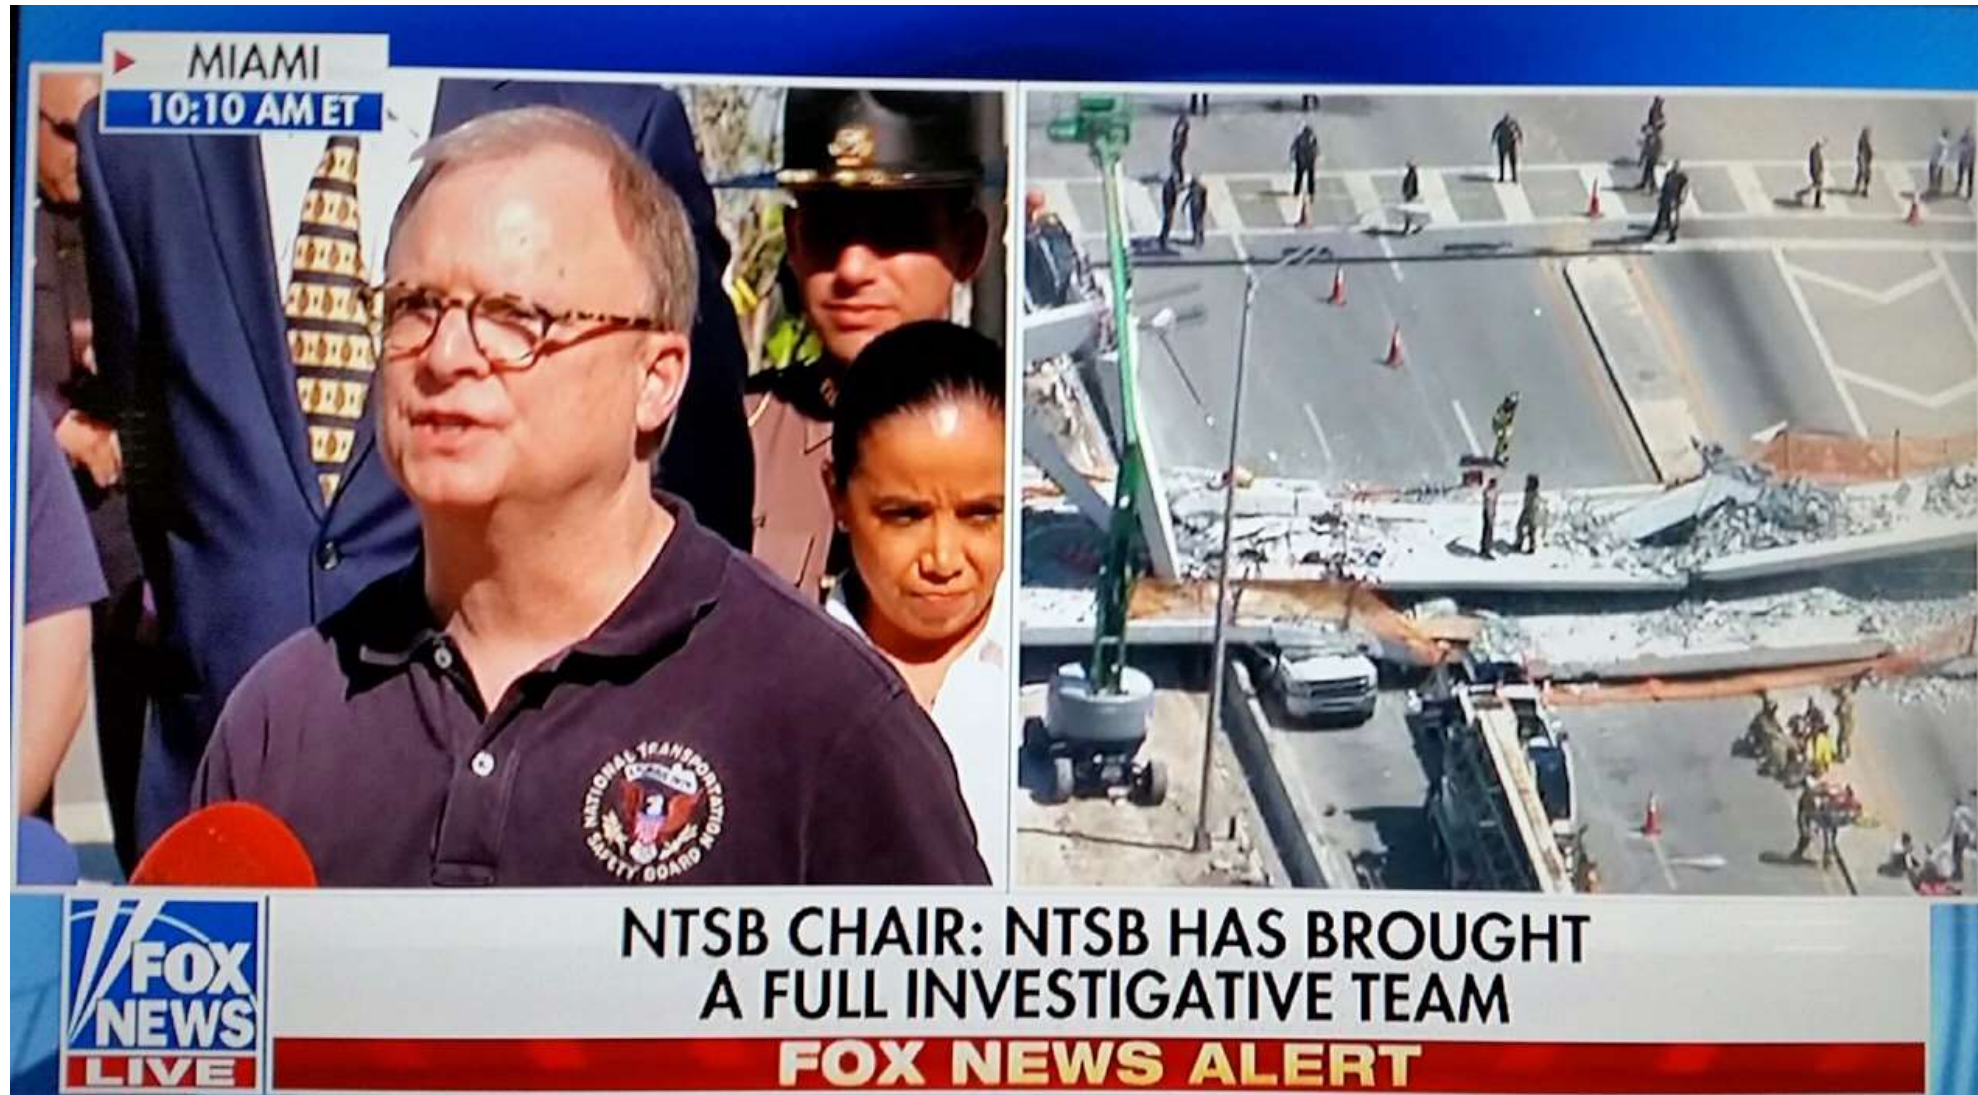
Conclusion

- Based on conservative calculations, it is concluded that the design meets LRFD strength requirements for this temporary condition ...
- And therefore there is no safety concern relative to the observed cracks and minor spalls

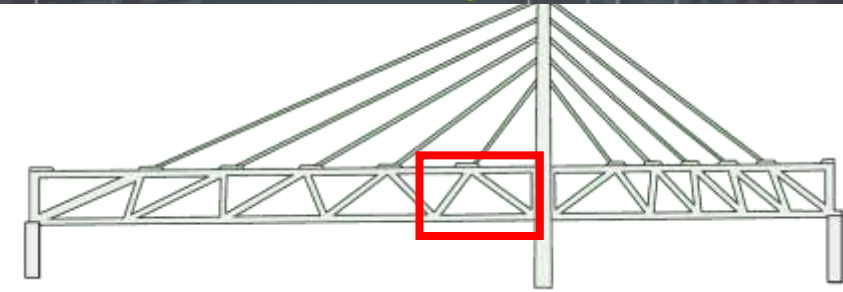
Forces on 11/12 nodal region

Magnitude of horizontal
force –
60 percent larger than
vertical force

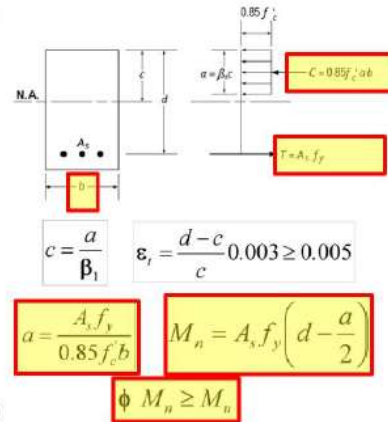
FIGG Presentation on Day of Collapse

Total Nodal Shear Stability

$$V_{mi} = c A_{cv} + \mu (A_s f_y + P_c)$$

- $c \times A_{cv} = 57.6 \text{ k/sf} \times 23.62 \text{ sf} = 1360 \text{ kips}$
- $M_u \times A_s F_y = 1.4 \times 22.72 \times 60 = 1908 \text{ kips}$
- $M_u \times P_c = 1.4 \times 520 \text{ kips} = 730 \text{ kips}$
- $= 3947 \text{ kips Total} = V_{ni}$
- FIGG's general preference is to neglect the Cohesion portion when practical. Thus, V_{ni} without "C" = 2638 kips
- $\Phi = 0.9$
- $\Phi(V_{ni}) = 3552 \text{ kips with "c"}$
- $\Phi(V_{ni}) = 2374 \text{ kips without "c"}$

- Steel Area = 13.1 in^2
- $T = (13.1)(60 \text{ ksi}) = 786 \text{ kips}$
- $f'_c = 8.5 \text{ ksi} = 1224 \text{ ksf}$
- $(a)(.85 f'_c)(b) = C = 786 \text{ kips}$
- Solving, " a " = 0.38 ft
- $M_n = (T)(d - (a/2)) = 786 \times 3.09' = 2398 \text{ kip-ft (nominal capacity)}$
- $\Phi = 0.9$, so $(\Phi)(M_n) = 2158 \text{ kip-ft}$
- Which is larger than $M_u = 2015 \text{ kip-ft}$
- Check OK

- Based on conservative calculations, it is concluded that the design meets LRFD strength requirements for this temporary condition ...
- And therefore there is no safety concern relative to the observed cracks and minor spalls

- The diagonal type cracks, in excess of FDOT criteria, should be sealed with approved methods and materials (Epoxy injection, etc.)
- The spalled areas have not been replicated by the engineering analyses. However ...
- The spalled areas are minor and it is recommended that they be prepared using normal procedures and poured back along with the upcoming "pylon diaphragm" pour (different from and prior to the falsework pours)
